UNITED SCRAP LEAD TROY, OHIO

SECOND FIVE-YEAR REVIEW REPORT

SEPTEMBER 2006

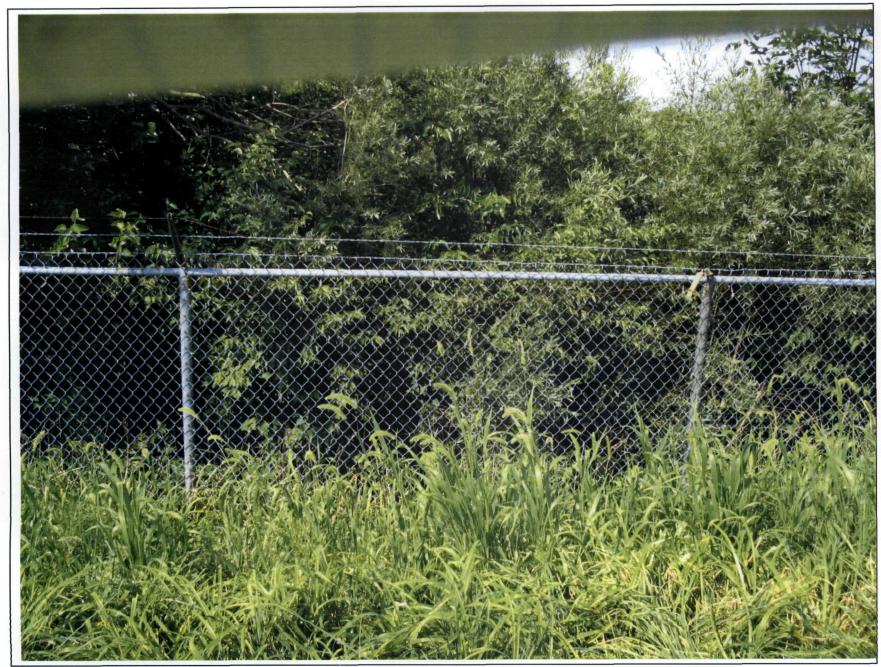
An inspection of the Site was conducted on July 28, 2004 by Ms. Nita Nordstrom of the Ohio EPA. According to the inspector, access to the Site was secure in most areas except for one area on the south side of the Site where the barbed wire and fence were damaged. The hole appeared to be large enough to allow entry by children, possibly adults, and smaller animals. There were no apparent signs of trespassing such as dirt bikes. The owner of the adjacent property when interviewed stated that deer sometime enter the property. The Site gates were locked and the "no trespassing" signs were located in areas where they could be easily viewed.

Figure 1. IMG - 2069 United Scrap Lead - Property South Border – Broken barbed wire at top of fence

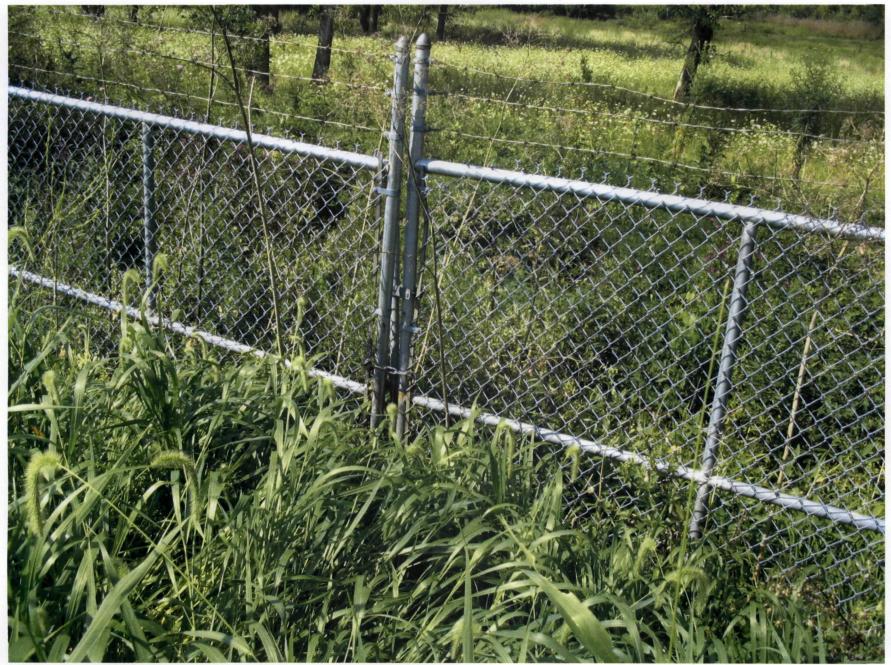
Figure 2. IMG - 2070 United Scrap Lead - Property South Border - Locked gate

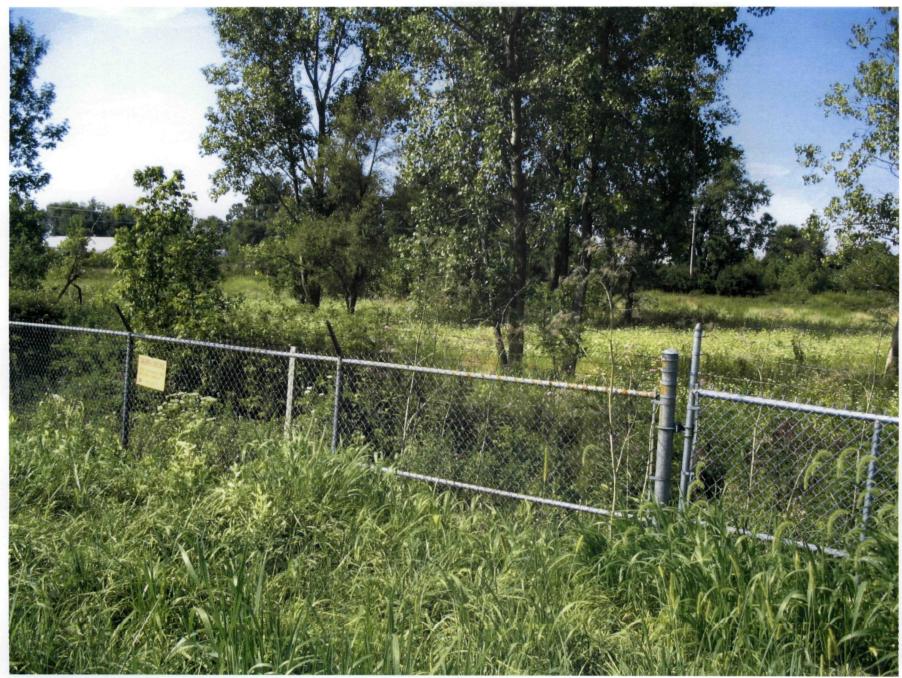
Figure 3. IMG – 2071 United Scrap Lead - Property South Border – Sign 1

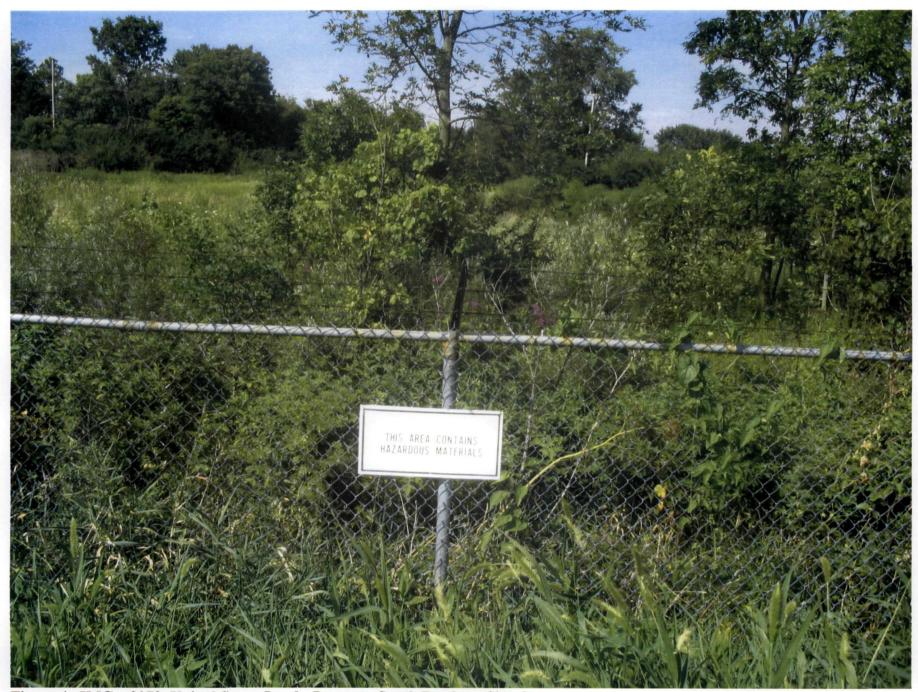
Figure 4. IMG – 2072 United Scrap Lead - Property South Border – Sign 2

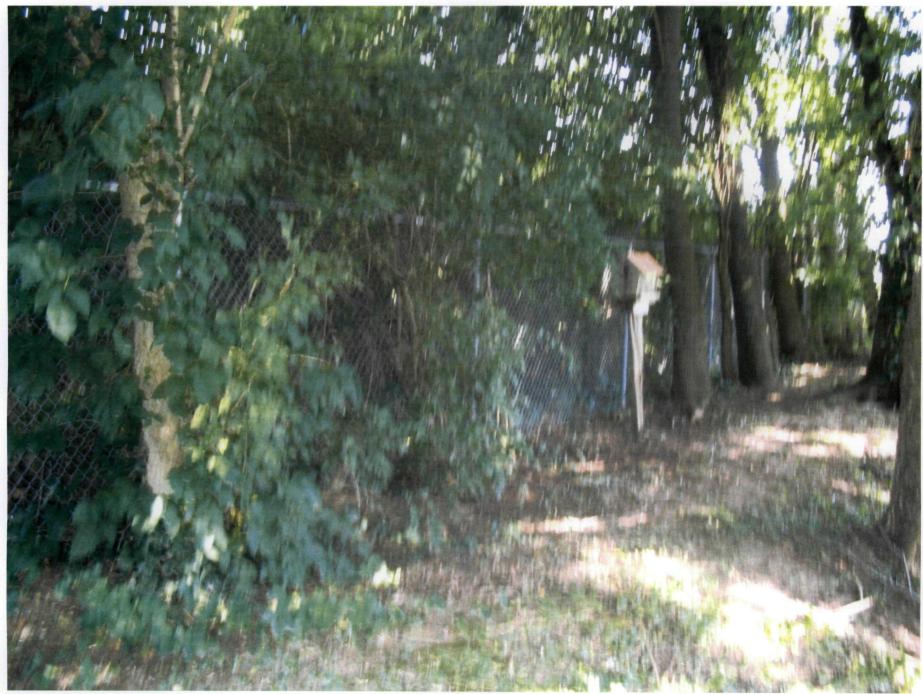
Figure 5. IMG – 2073 United Scrap Lead - Property West Border – Fence

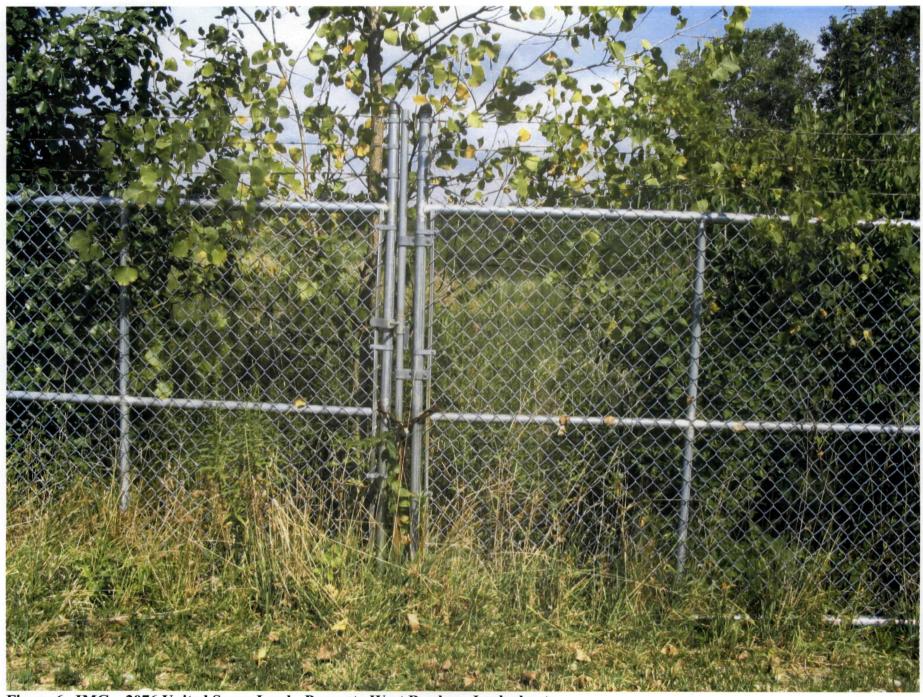
Figure 6. IMG – 2076 United Scrap Lead - Property West Border – Locked gate

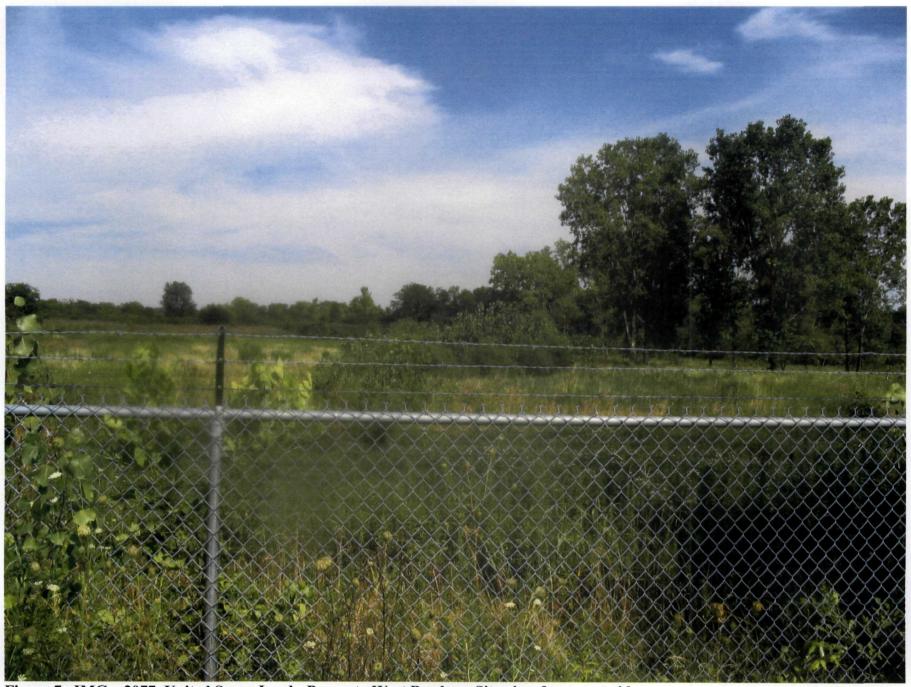
Figure 7. IMG – 2077 United Scrap Lead - Property West Border – Site view from west side

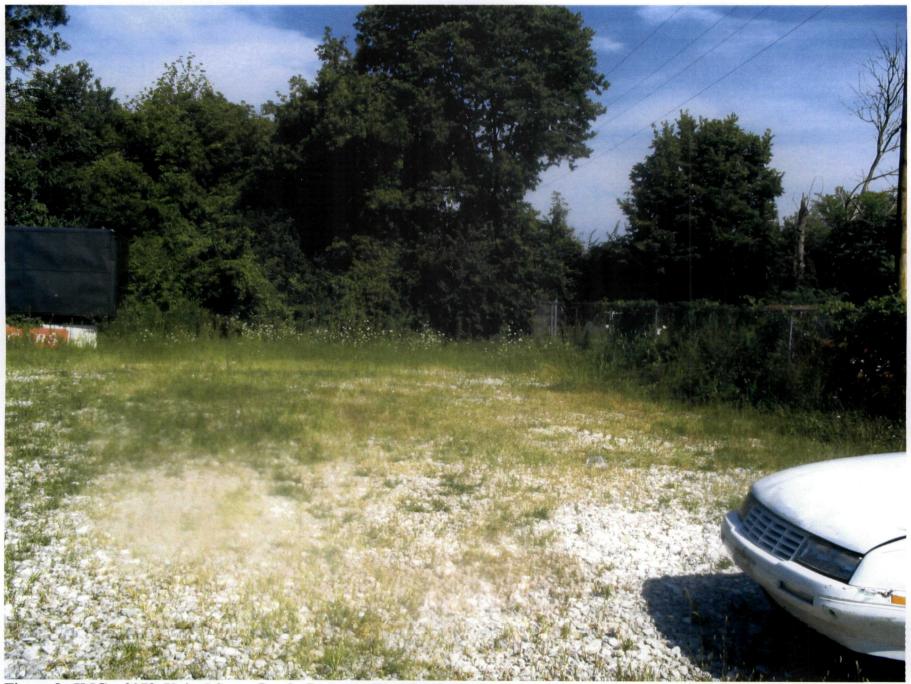
Figure 8. IMG – 2078 United Scrap Lead - Property West Border – Overgrowth (behind auto dealership)

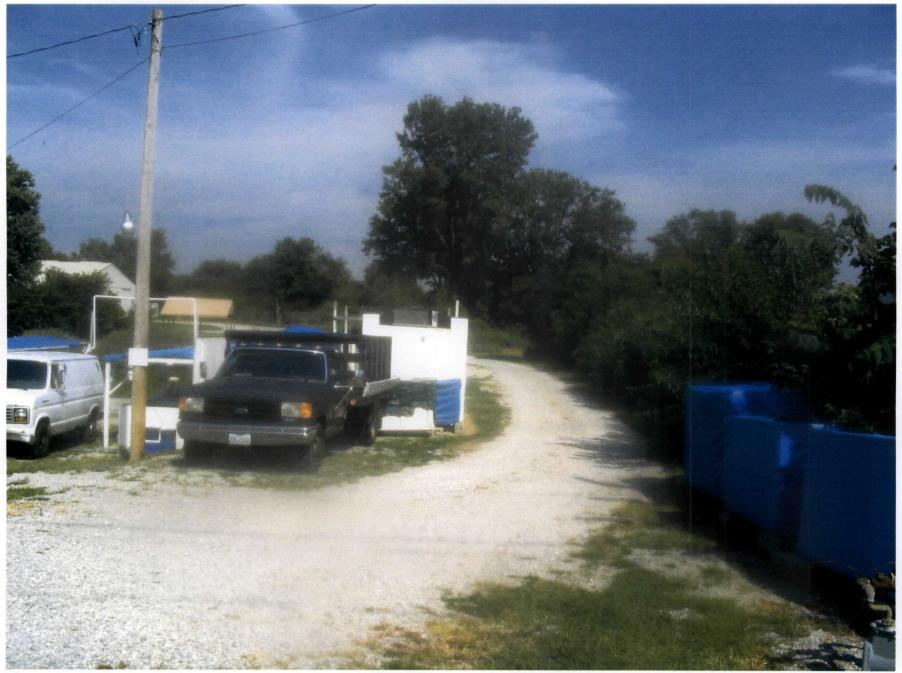
Figure 9. IMG – 2079 United Scrap Lead - Property West Border – Back of aquaculture

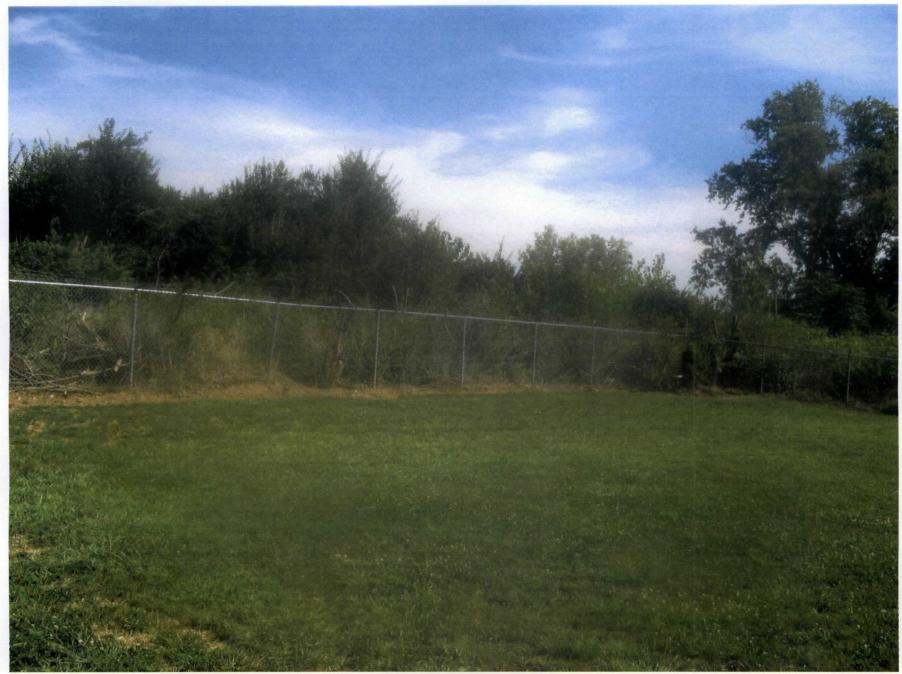
Figure 10. IMG – 2080 United Scrap Lead - Property West Border - Behind private residence

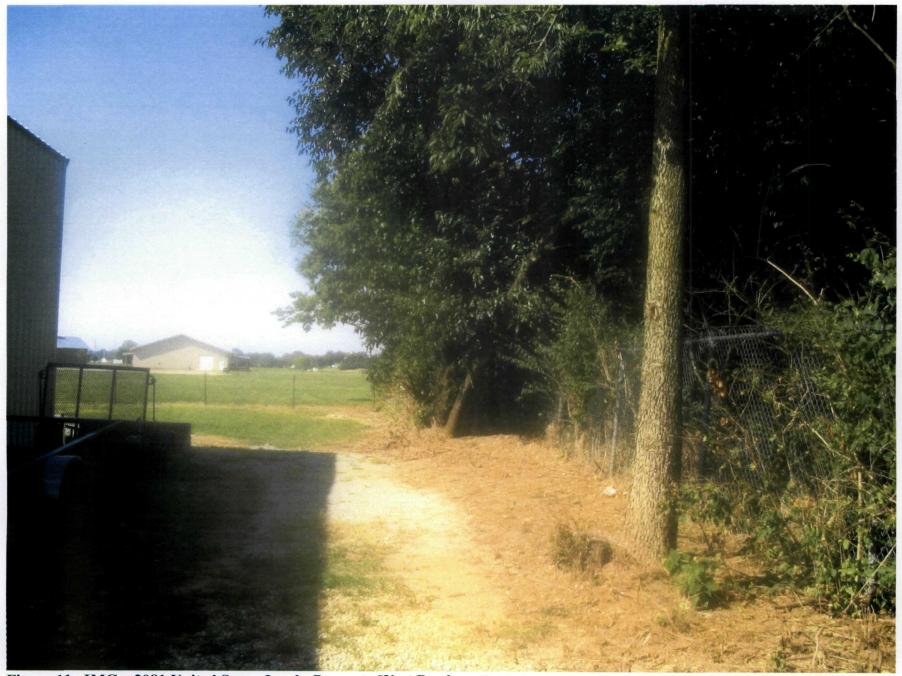
Figure 11. IMG - 2081 United Scrap Lead - Property West Border - Behind private residence facing north property access road

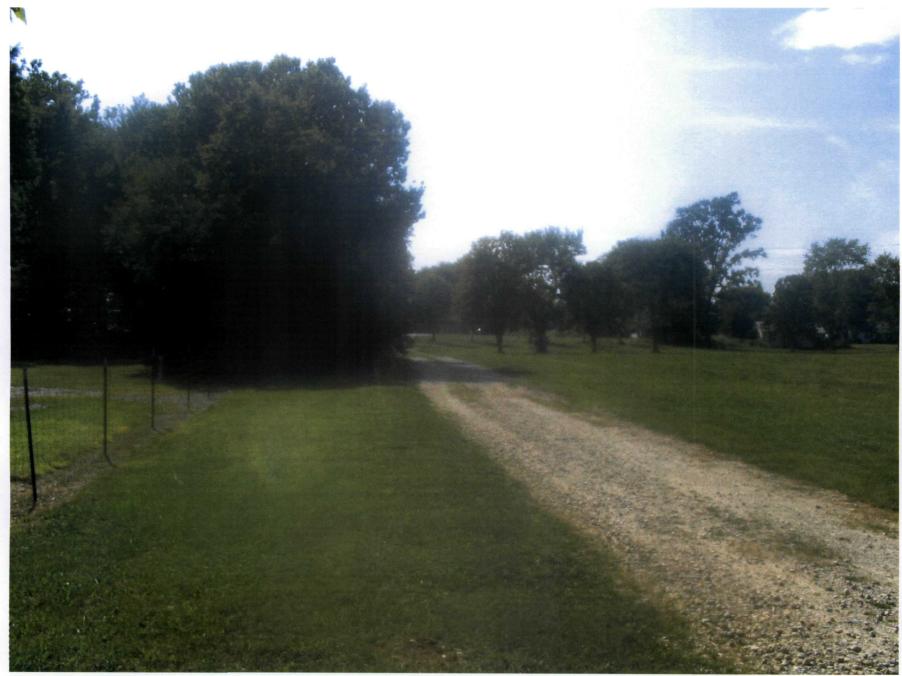
Figure 12. IMG – 2082 United Scrap Lead - Property North Border – North access road facing west (SR25)

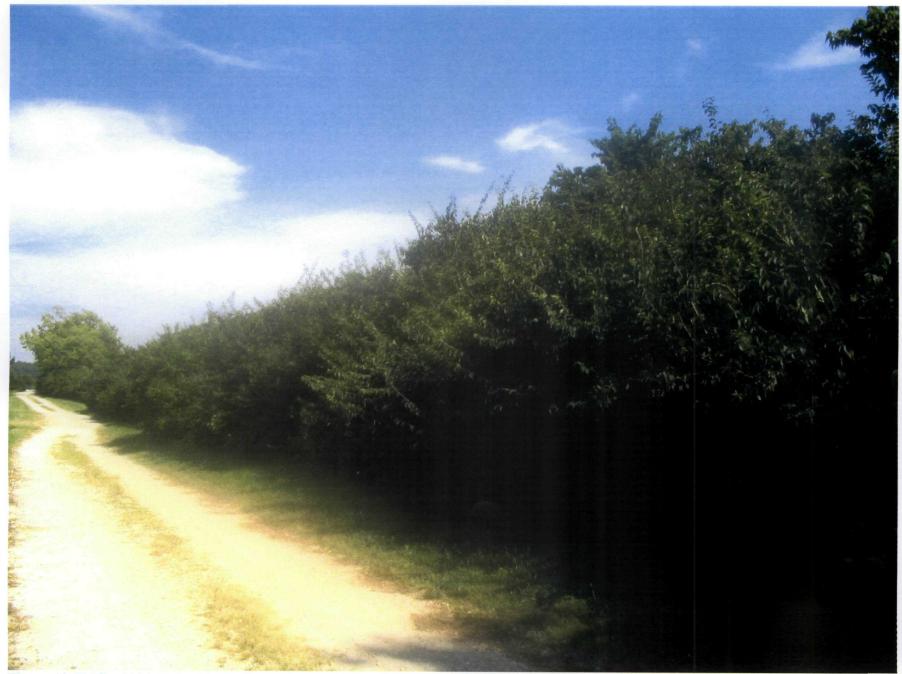
Figure 13. IMG – 2084 United Scrap Lead - Property North Border – North access road facing east (R R tracks) –showing overgrowth at fence line

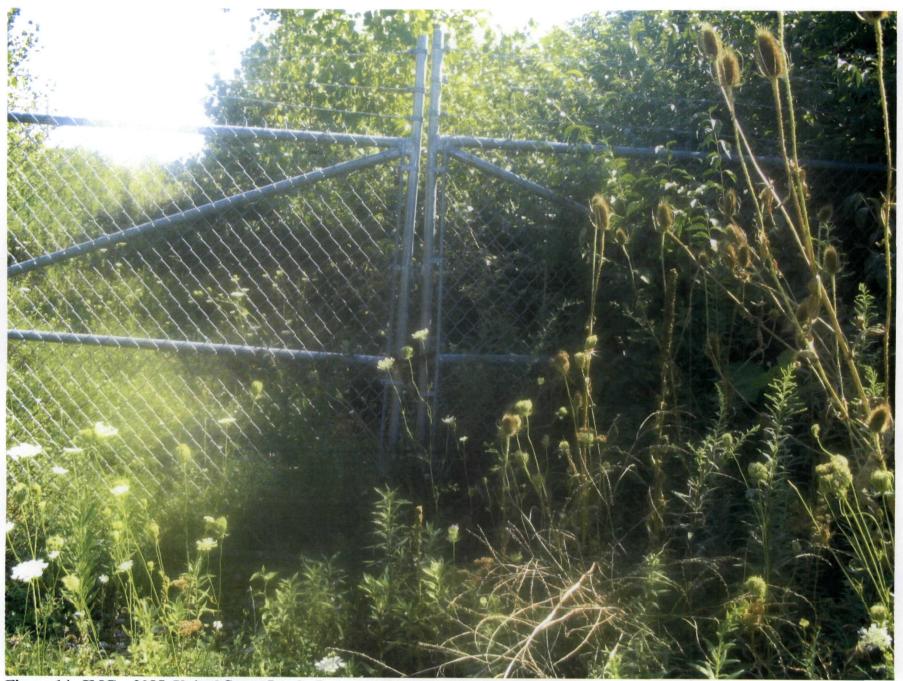
Figure 14. IMG – 2085 United Scrap Lead - Property North Border – (North access road) – Locked gate 1

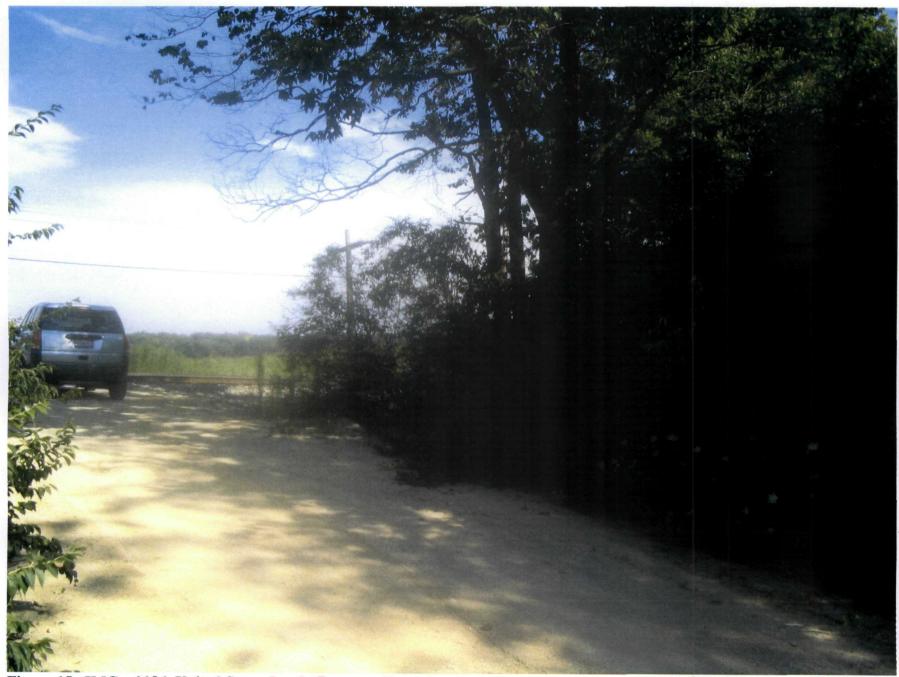
Figure 15. IMG – 2086 United Scrap Lead - Property North Border – (North access road) – Locked gate 2

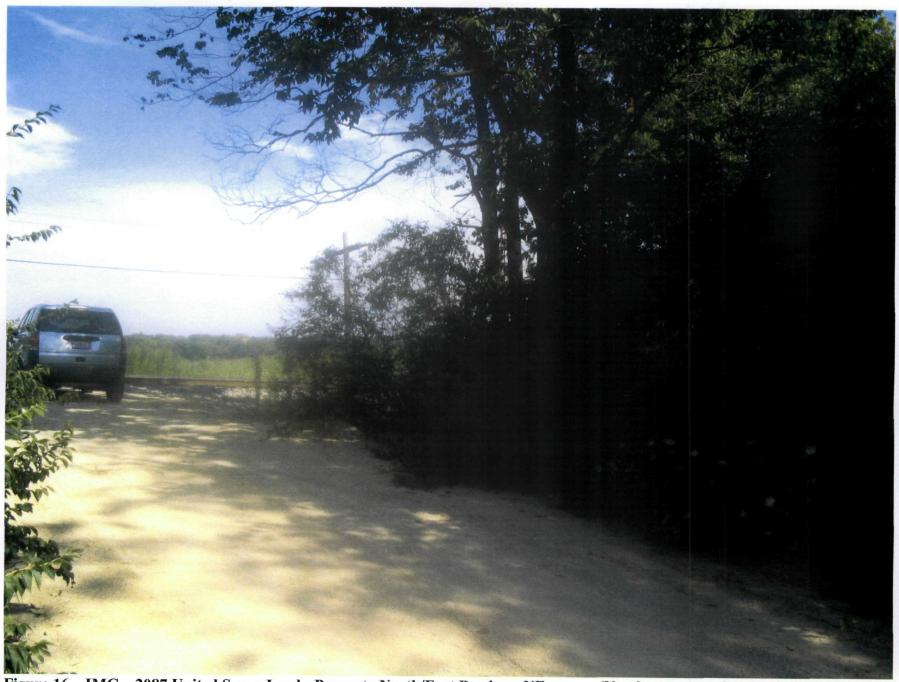
Figure 16. IMG – 2087 United Scrap Lead - Property North/East Border – NE corner (North access road and railroad tracks)
